THE RESULTS OF FIFTY YEARS MONITORING OF THE STRAIN DYNAMICS OF THE FAULT CROSSING THE LARGE ENGURI DAM FOUNDATION

Key words: *Enguri Dam, fault crossing dam foundation, fault strain dynamics*

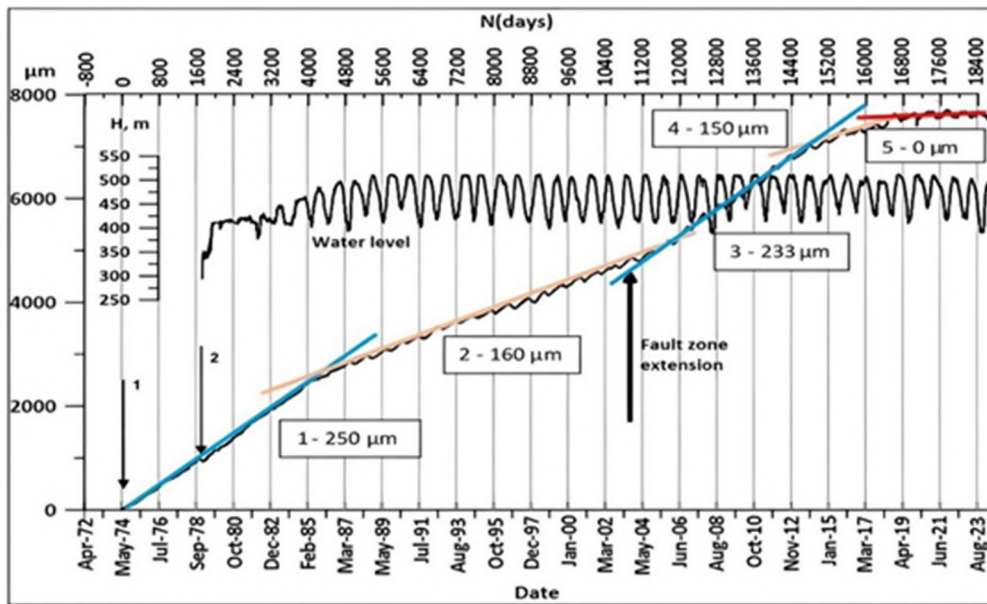
The strain rate history of the branch fault crossing the Enguri Dam is complicated: it reflects the strong variations in the slip velocity [5]. The initial strain rate (SR) values for 1974-1985 reflect the natural (tectonic) component dynamics of the fault strain rate: $V_1 = 250 \mu\text{m}/\text{year}$; this SR characterizes the mechanical properties of the natural system of force chains in the fault gorge under the natural strain rate. In the following 1985-2004 period velocity decreased to $V_2 = 160 \mu\text{m}/\text{year}$, which can be due to the damage of the initial system of force chains in the fault volume by water load cycles as a result of the reversed-stress fatigue effect. In the following epoch (2004-2013) the strain rate V_3 increases to almost initial value $V_3 = 233 \mu\text{m}/\text{year}$, which can be interpreted as the result of temporary healing of disrupted force chains. In the following period V_4 the strain rate decreased again to $150 \mu\text{m}/\text{year}$, i.e. it almost returns to V_2 , which again can be explained by the repeated weakening of force chains in the fault gorge. This repeated pattern of slip from 1974 to 2013 can be explained by the quasiperiodic slip process with alternating velocity of slip, due to varying fault surface roughness.

In the last years, 2019-2024 the strain rate abruptly fell to zero: $V_5 = 0 \mu\text{m}$. The change of the strain regime in the last years can be connected either with the final stabilization of the fault or with a temporary full braking of the fault motion by a strong asperity/asperities on the fault interface. In the last case, the stress on the fault will build up, till attaining the critical stress value, necessary for overcoming the resistance of asperity/asperities in a dynamical manner. The dynamical discharge of the accumulated energy can generate an earthquake. Taking into consideration the length of the dam-crossing fault (2-3 km) the magnitude of EQ can be of the order of M3-4 [6,7], which should not be dangerous the dam structure, as according to previous engineering assessment [8], the Enguri Dam should withstand the impact of the maximal expected earthquake of magnitude M8.

Table 1. Periods with different strain rates of trend, from the data, presented in Fig. 4.

Number of periods	Periods: month, years	Strain rate α in the period, microns/year
1	May 1974-Feb. 1985	250
2	Feb. 1985-May 2004	160
3	May 2004-May 2013	233
4	May 2013-Apr. 2019	150
5	Apr. 2019-Aug.2024	0

Fig. 4. WL in the Enguri lake from 1978 (upper curve) to 2023 and the data of the extension/compaction of the branch of the large Ingrishki fault, crossing the foundation of the dam (lower curve). Arrow 1 corresponds to the start of strain-meter monitoring and arrow 2 – to fault compaction by approximately $90 \mu\text{m}$ at WL, rising to 100 m in 1978. The upper horizontal axis shows the number of days from the zero day (1 May 1974) to August 2024. Note different strain rates during 50 years of the observation period.
