THE MAIN CAUSES OF ACTIVATION TWO LARGE LANDSLIDES OF THE DEBED RIVER GORGE IN XXI CENTURY

Ayrum (Bagratashen) landslide-collapses of 02.10.2011

Tumanyan landslide 12.01.2018

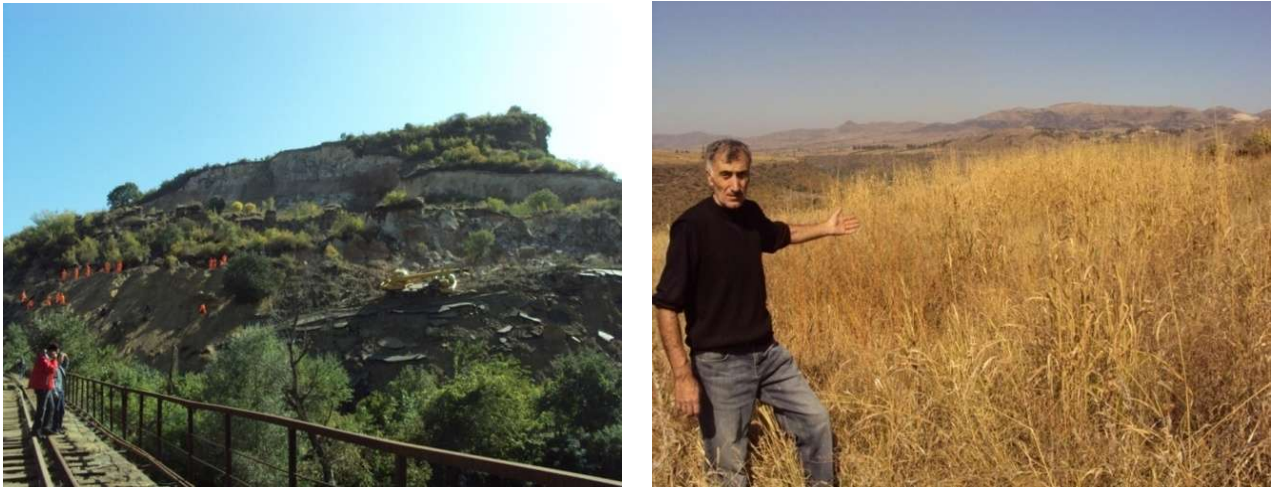
Fig. 1. Overview of Ayrum landslide-collapse area (the basalt cover is destroyed). On the site, above the collapse, the ground is water-saturated, wetlands.

The situation in the area adjacent to the landslide-collapse head. No noticeable cracks or other deformations were found in this area due to the presence of basalt cover. In the southern part of the landslide there is groundwater outlet, and above (on the platform) there are irrigated lands and swamps with an area of 500 m², including reeds. This indicates of the additional moisture of. The area above the landslide is unstable. Only large-scale collapses are possible here, due to basalt cover.

Possible causes of landslide-collapses. The slope was in the ultimate stress (stable) state before the landslide occurred. Any additional effects could lead to loss of stability. One of these additional effects, was the September 27 earthquake in Dmanisi (Georgia), with a intensity of 5-6 point by EMS-98 (M=4.4), which had a intensity of 3-4 in the study area. Were it not for the earthquake and heavy equipment on the highway, it would still be in the future landslide zone. In other words, the impact of the earthquake and heavy equipment could not be the cause of the landslide; they just contributed to its activation.

Conclusions: 1. Cause of landslide-collapse is the long-term wind blowing of the slope, ultimate stress state and additional moistening of loess soils. The impact of the earthquake and heavy equipment were factors contributing to the activation of landslide-collapse; 2. The landslide body is currently in a very unstable state, any intervention can lead to new movements of the masses; 3. Given the situation, the best decision is to build a new, landslide-bypassing highway. Unpredictable consequences are possible on the restored road due to the presence of weak loess soils.

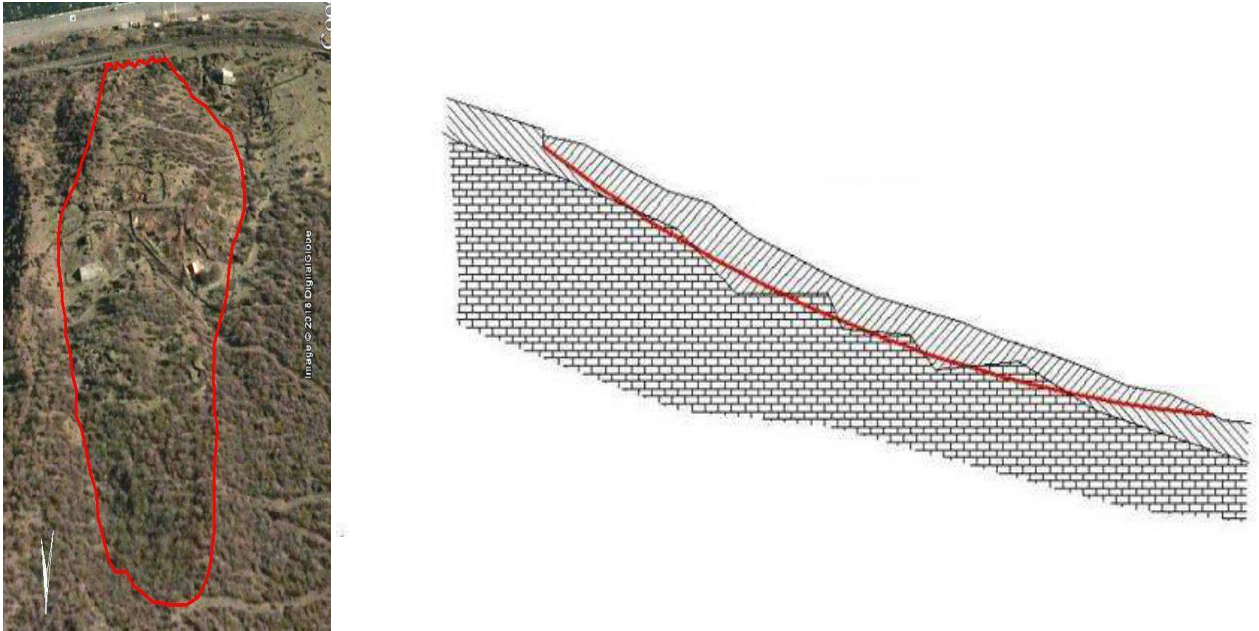
Fig. 2. General view Tumanyan landslide on satellite image and schematic section of the landslide area.

General brief description of the landslide. The landslide is located in against of Tumanyan community of Lori region, in the area directly adjacent to the railway on the left bank of the Devbet river. Man-made factors also take place here; these are mainly construction and operation of the water line serving the brick factory (especially the pool that extinguishes the water pressure). The outline of the landslide body is clearly visible in the satellite photos taken 10 years ago (Fig. 2).

Peculiarities of landslide structure. The landslide is located on the northern denudation slope of Lori deep gorge. Here various deluvial formations cover the radical volcanic basalts. Slope and landslide body soils are represented by loam with various debris content. Often the volume of fragments increases and the soils

according to the classification become large grains with the content of stones. Groundwater is practically non-existent, there is no fixed groundwater horizon. The landslide body stretches up to 320 m and has more than 3 hectares area (32500 m^2 area and about 35000 m^3 volume). Among the features of the landslide it is necessary to mention: a) almost the entire surface of the landslide body, except for the collapse site on the tongue, is represented by a thickness of 4 m, with solid or semi-solid ground crust; b) the basalt foundations of the landslide body have protrusions and grooves that cross the landslide slide surface (Fig.2; Fig.3); c) surface water has no significant effect: d) within the collapsed tongue of the landslide, rapid discharge of accumulated water is observed.

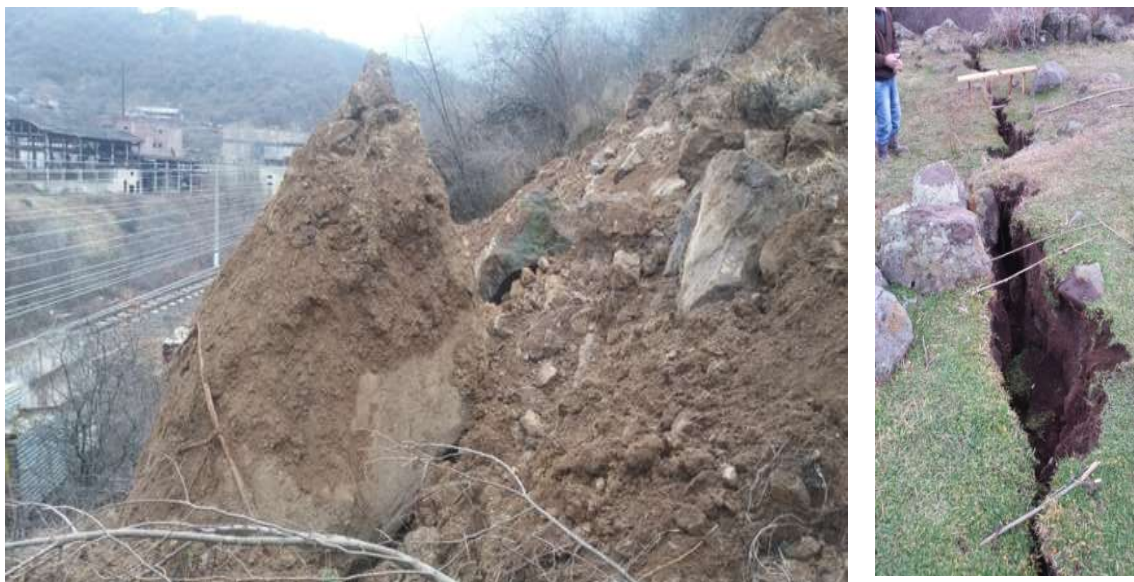
Fig. 3. The view of the Tumanyan landslide (the threat of a displaced mass on the rail) and the crack at the top, on which beacons are placed to record the movements.

The situation in the landslide zone. As of January 13, 2018, the landslide had stabilized as the flow of water through the pipeline was stopped. The possible proofs of this are: a) 1955 u 1988-1989 after activation, when the flow of water from the pipeline to the landslide body was eliminated, the movement of the landslide stopped; b) this time, when the operation of the water line was stopped, the landslide was stabilized; c) the volume of water flowing out of the landslide site near the railway has significantly decreased. In 2018 the displacements caused by the landslide were smaller than the previous ones. Thus, if the horizontal displacements due to the observed activation in the fracture cracks up to 3-4 m depth are 30-50 cm, then they have previously reached meters. The difference between the amplitudes of the old and new vertical displacements at the head of the landslide is obvious. Old, 1989 the vertical drop amplitude of the resulting fault is at least 1.5 m, and in the new fault 0.3-0.4 m.

Conclusions: The cause of all three landslide activations is man-made and was due to water pipe accidents and water penetration into the landslide body. Due to the large mass of the landslide body, the known methods of stabilizing it (construction of a retaining wall, installation of pile, etc.) are not effective. In this situation, the only correct approach to the landslide body is to stop the entry of water, which has already been done.
